Contract #: 04-0120F4Cty: SF/ALA Rte: 80 PM: 13.2/13.9File #: 82.28**WELDING INSPECTION REPORT****Resident Engineer:**Siegenthaler, Peter**Address:** 333 Burma Road**City:** Oakland, CA 94607**Report No:** WIR-025241**Date Inspected:** 05-Jul-2011**Project Name:** SAS Superstructure**OSM Arrival Time:** 630**Prime Contractor:** American Bridge/Fluor Enterprises, a JV**OSM Departure Time:** 1500**Contractor:** Westmont Industries**Location:** Santa Fe Springs, CA**CWI Name:** Christopher Concha**CWI Present:** Yes No**Inspected CWI report:** Yes No N/A**Rod Oven in Use:** Yes No N/A**Electrode to specification:** Yes No N/A**Weld Procedures Followed:** Yes No N/A**Qualified Welders:** Yes No N/A**Verified Joint Fit-up:** Yes No N/A**Approved Drawings:** Yes No N/A**Approved WPS:** Yes No N/A**Delayed / Cancelled:** Yes No N/A**Bridge No:** 34-0006 L & R**Component:** Maintenance Travelers**Summary of Items Observed:**

On this date, Caltrans Quality Assurance Inspector (QA) Sherri Brannon is present at the Westmont Industries (WMI) jobsite in Santa Fe Springs, California for the purpose of observing fabrication and QC functions for the SAS Superstructure, Bid Item #99, Maintenance T

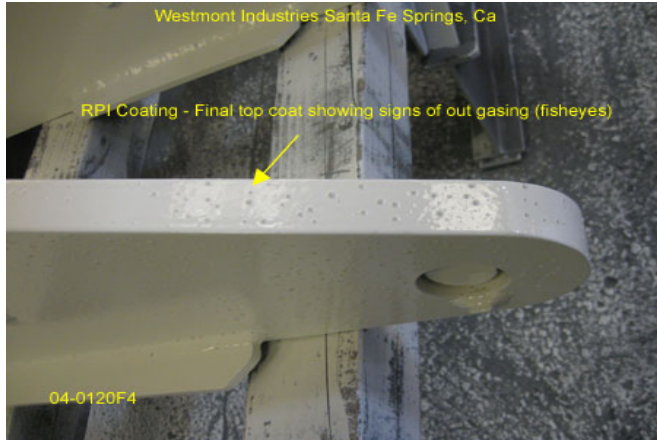
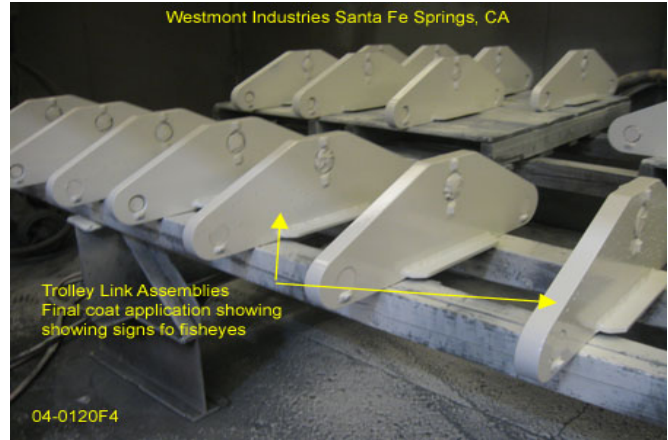
QA Inspector asked Mr. Ron Ybarra if RPI was going to start applying the final coat to the link assemblies today. Mr. Ybarra stated that RPI is going to start applying the final top coat today. QA Inspector noticed after RPI started applying final coat QA Inspector had noticed out gassing (fisheyes) in the top coat on most of the link assemblies and that RPI had applied the final coat over areas of mudcracking in the joints today. Note: RPI did not water blast prime coated before applying the final coat and had coated over several areas of mudcracking and areas of on the prime coat that exceeded prime coating thickness requirements per Special Provisions. This QA

Inspector was informed by RPI Coating Mr. Carlos Torres that RPI will have the Sherman Williams Representative on site tomorrow to help RPI figure out what caused the out gassing (fisheyes) in the top coat applied today. QA Inspector informed SMR Mr. Nicolai Hvass and QA Inspector Mr. Fintan Shanley of the above information.
